DATE: OCTOBER, 2004
 JOB NUMBER: 2056
 SOURCE: BASE MAP PROVIDED BY LAKE MONTICELLO OWNERS ASSOCIATION

COVE TRANSECTS

LAKE MONTICELLO

FLUVANNA COUNTY, VIRGINIA

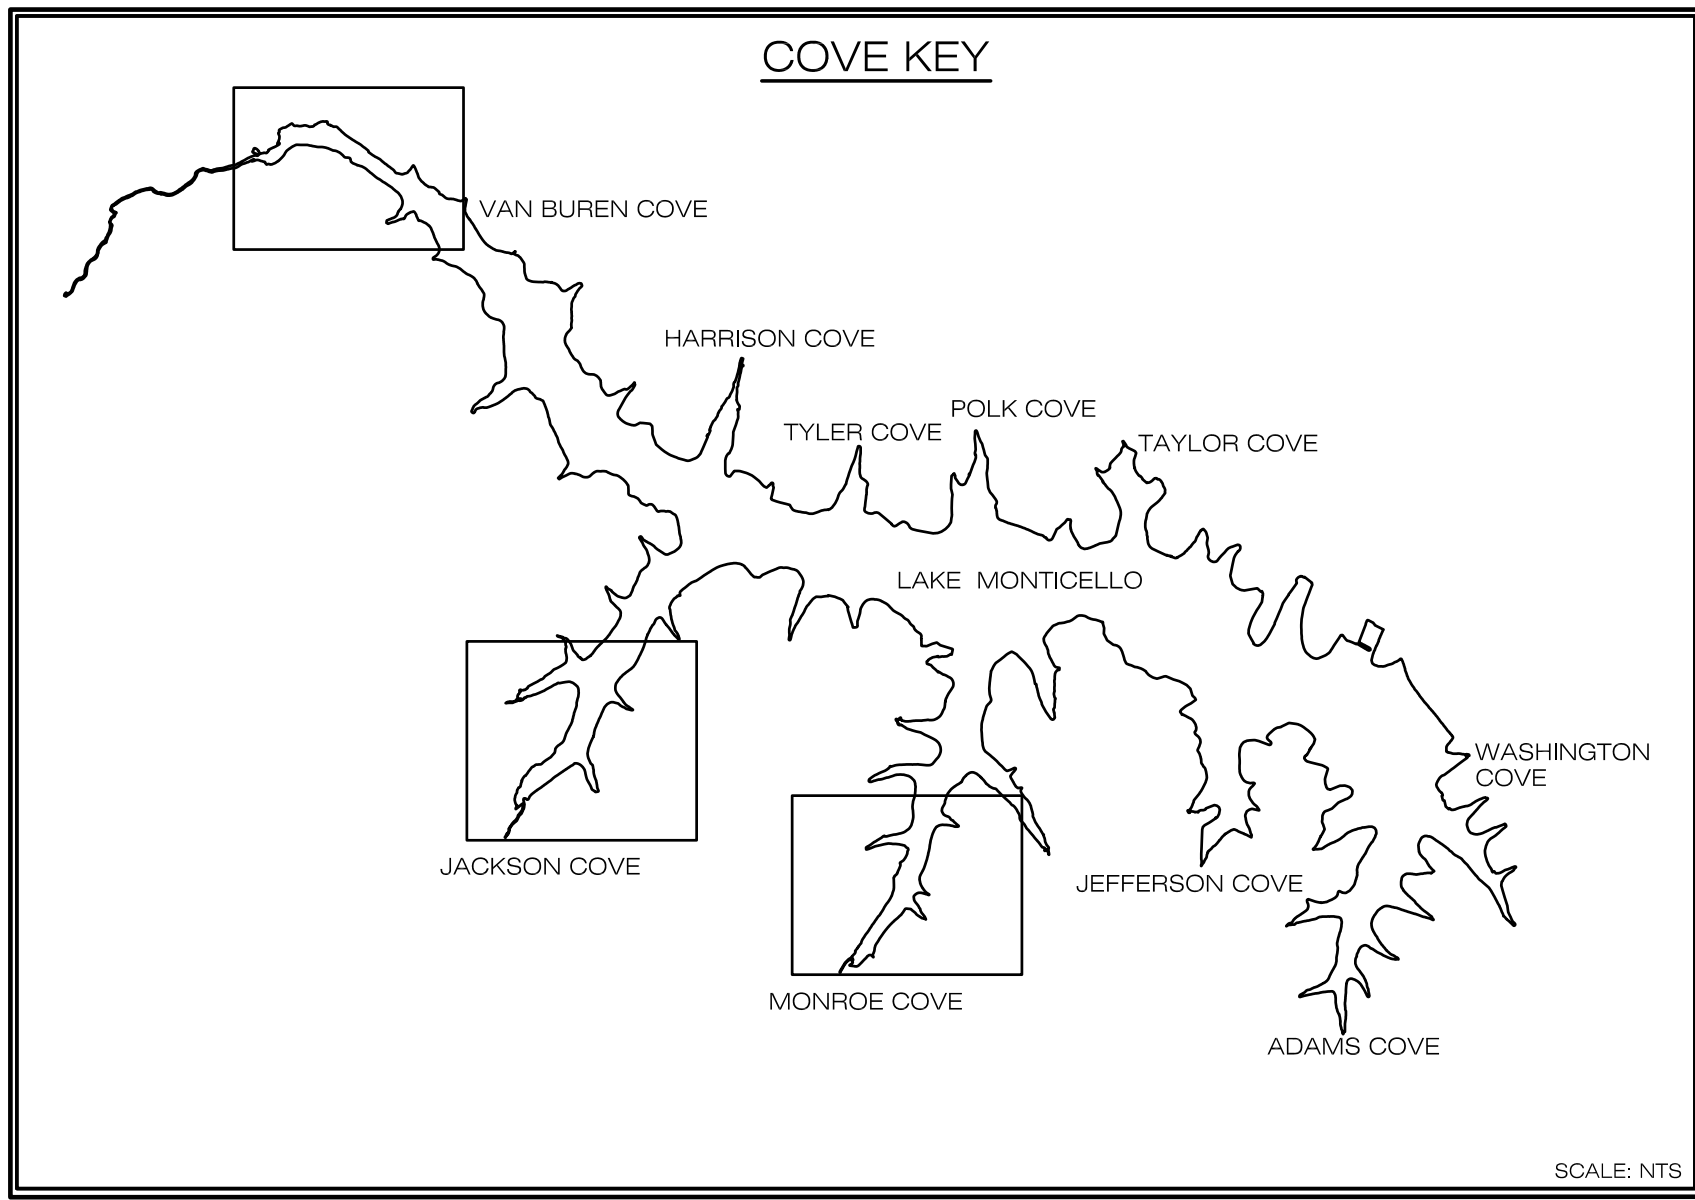
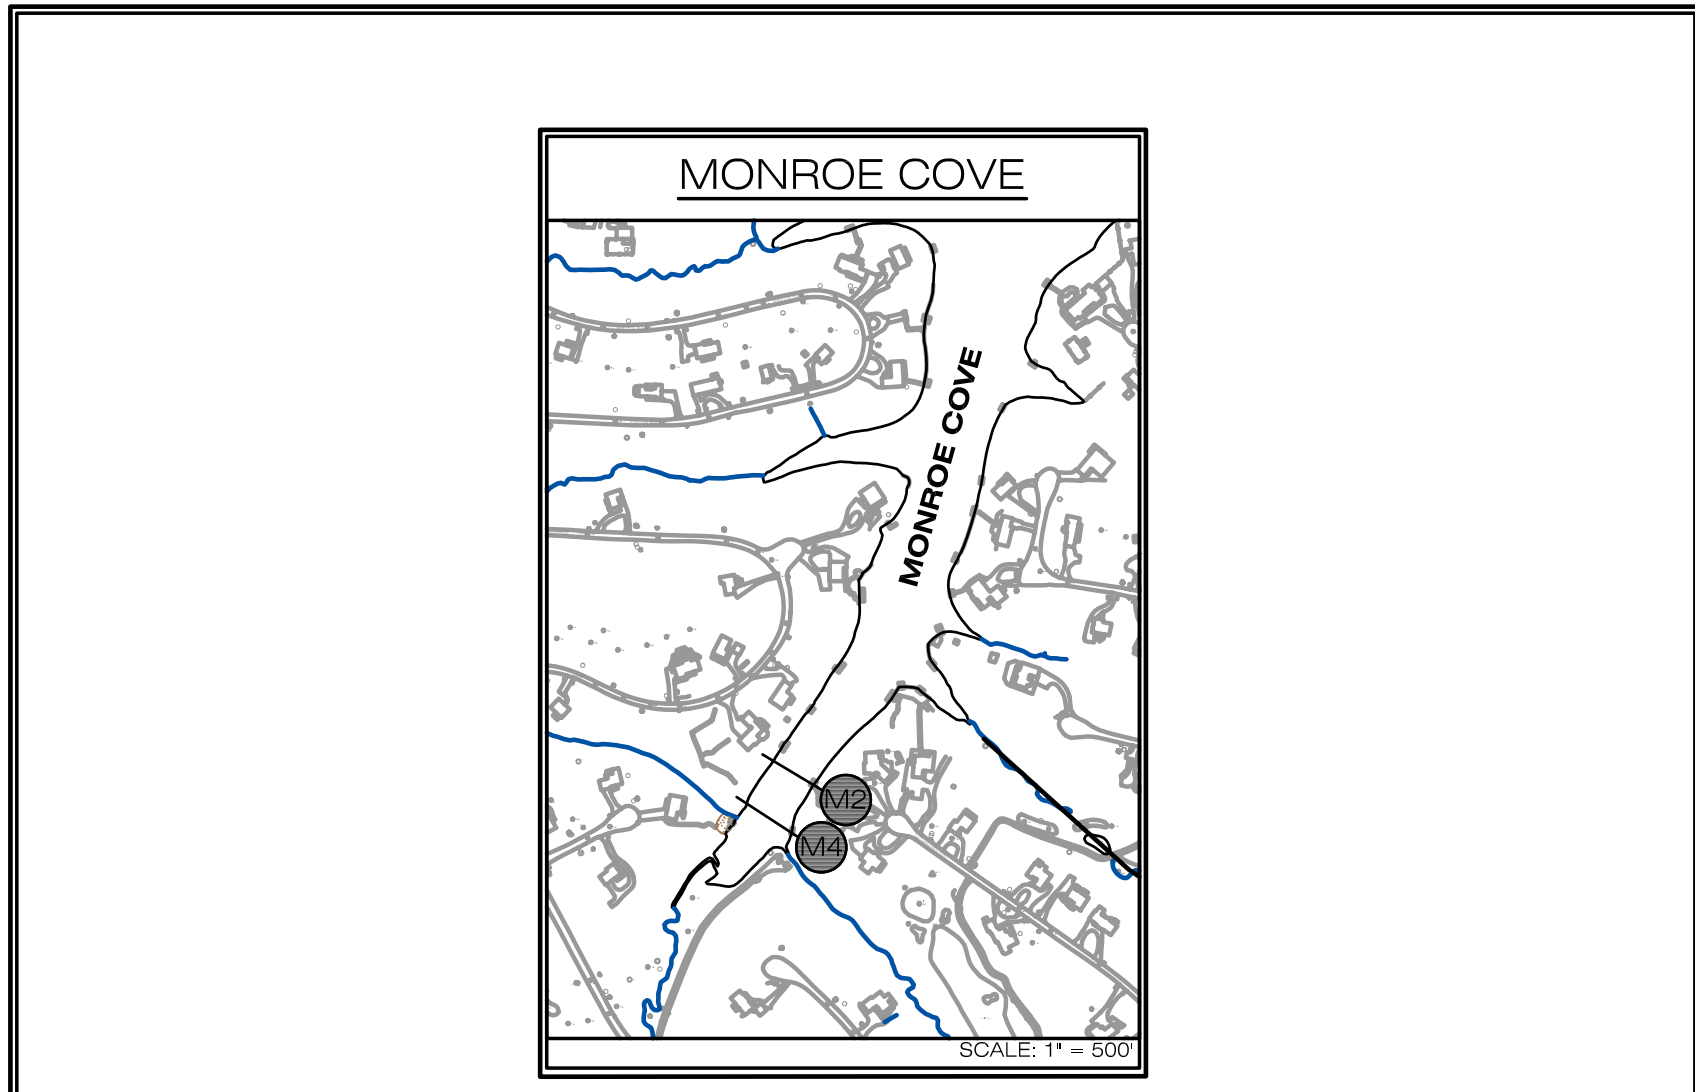
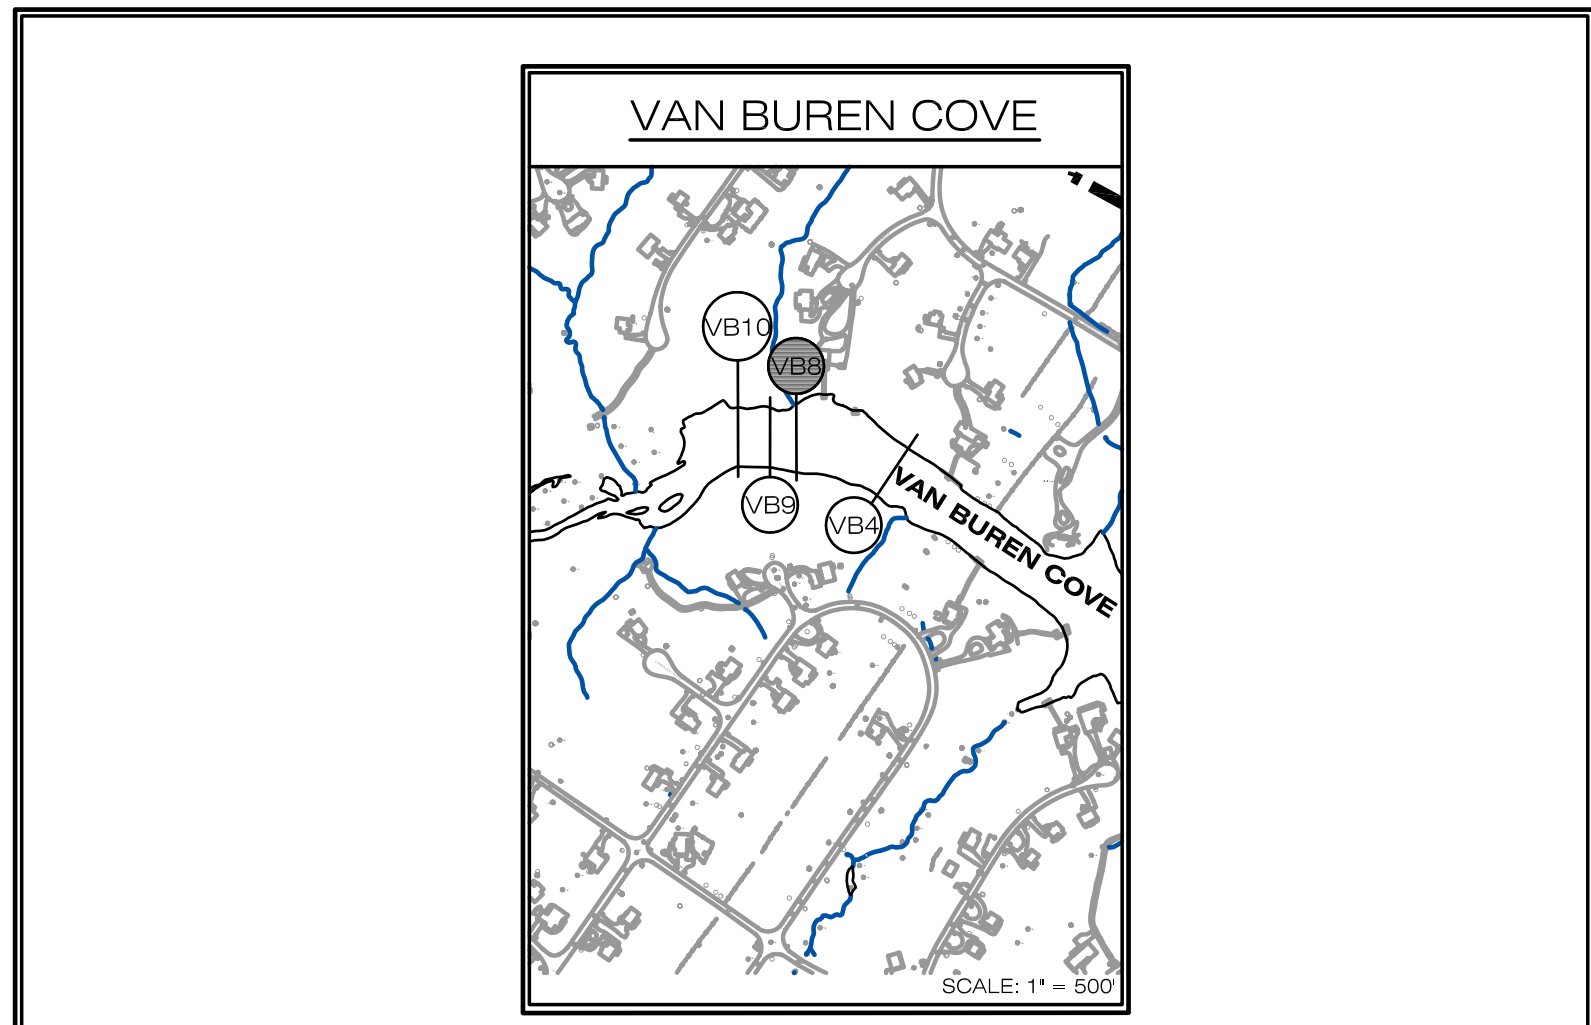
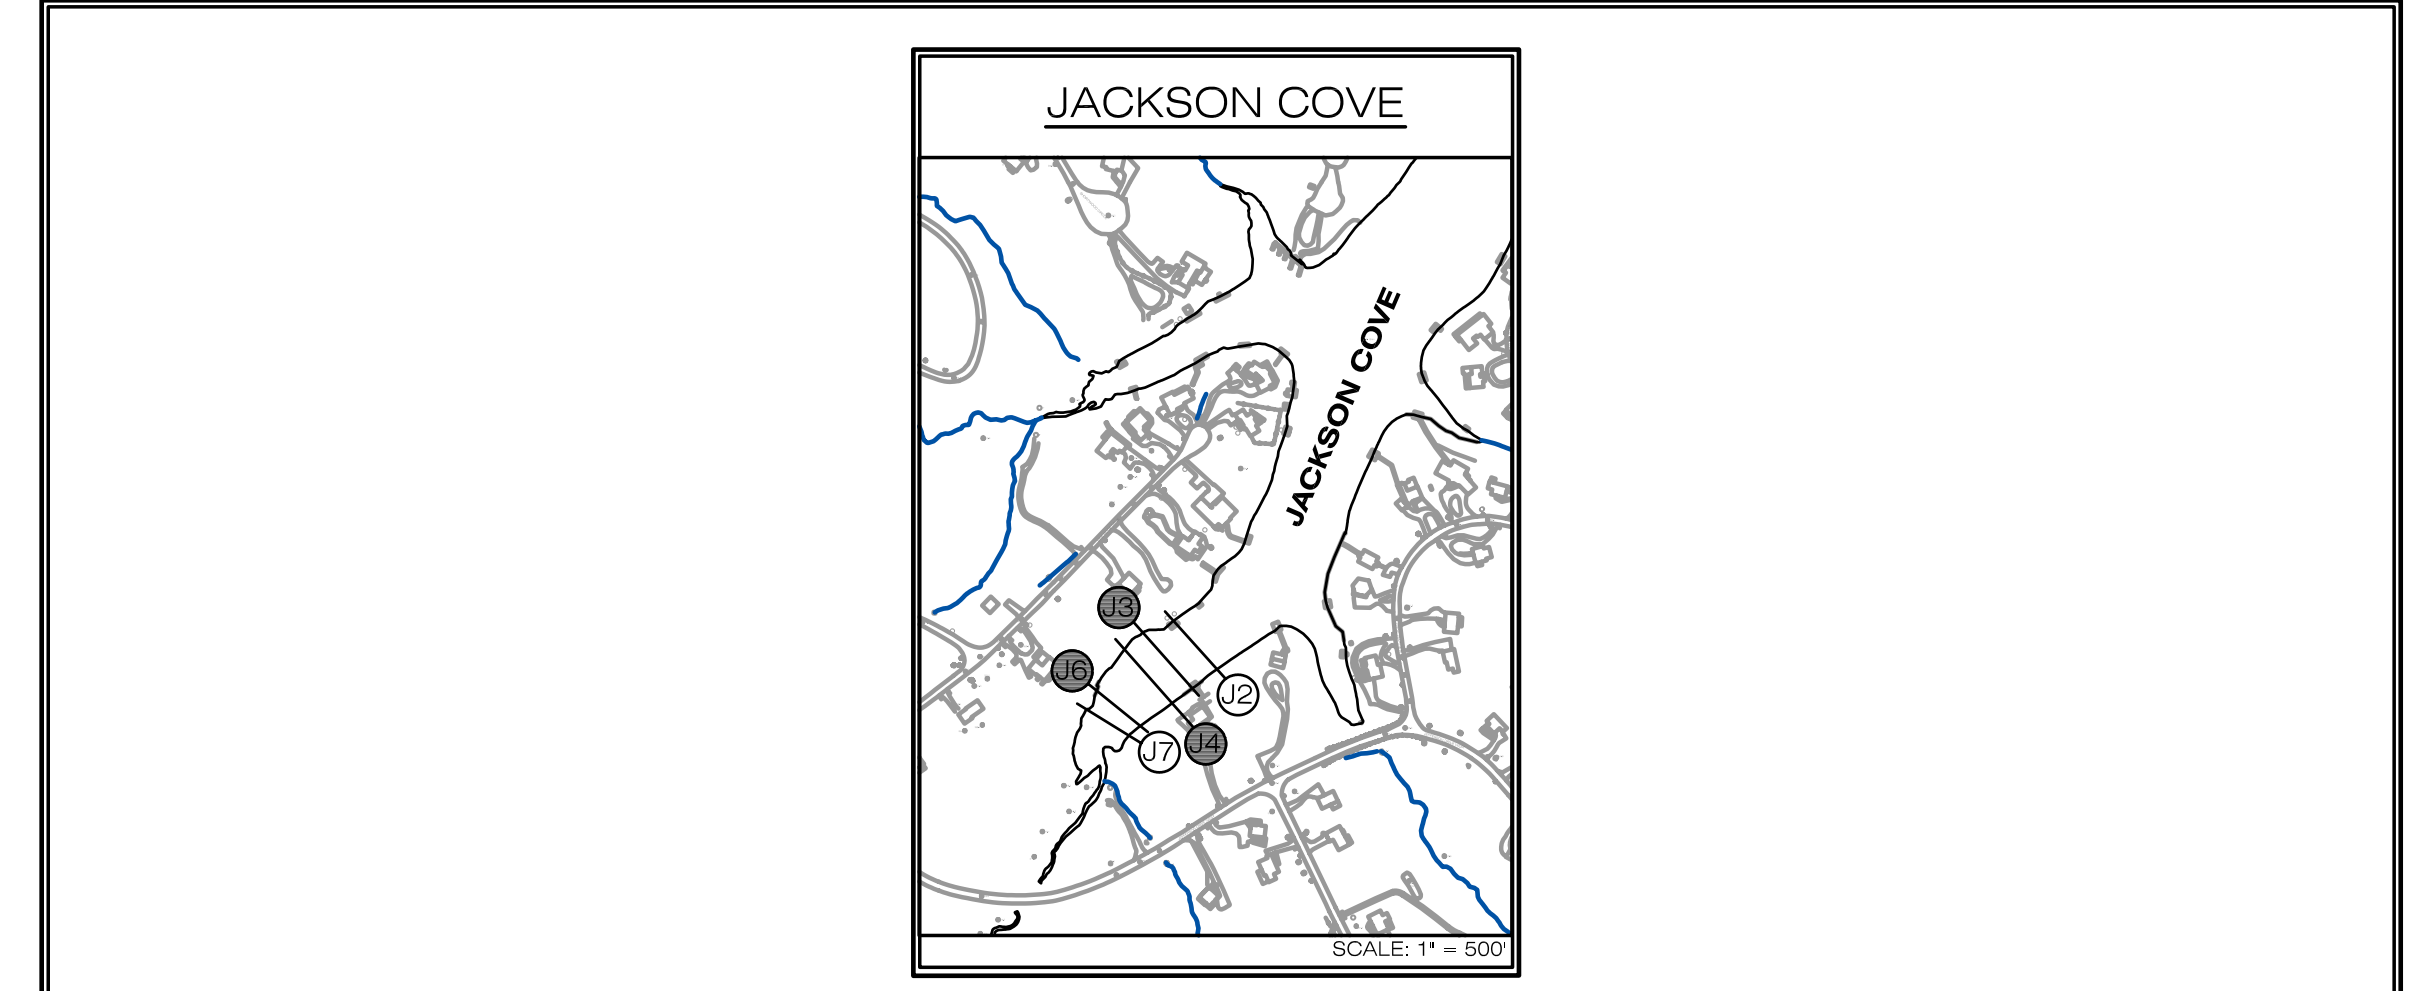
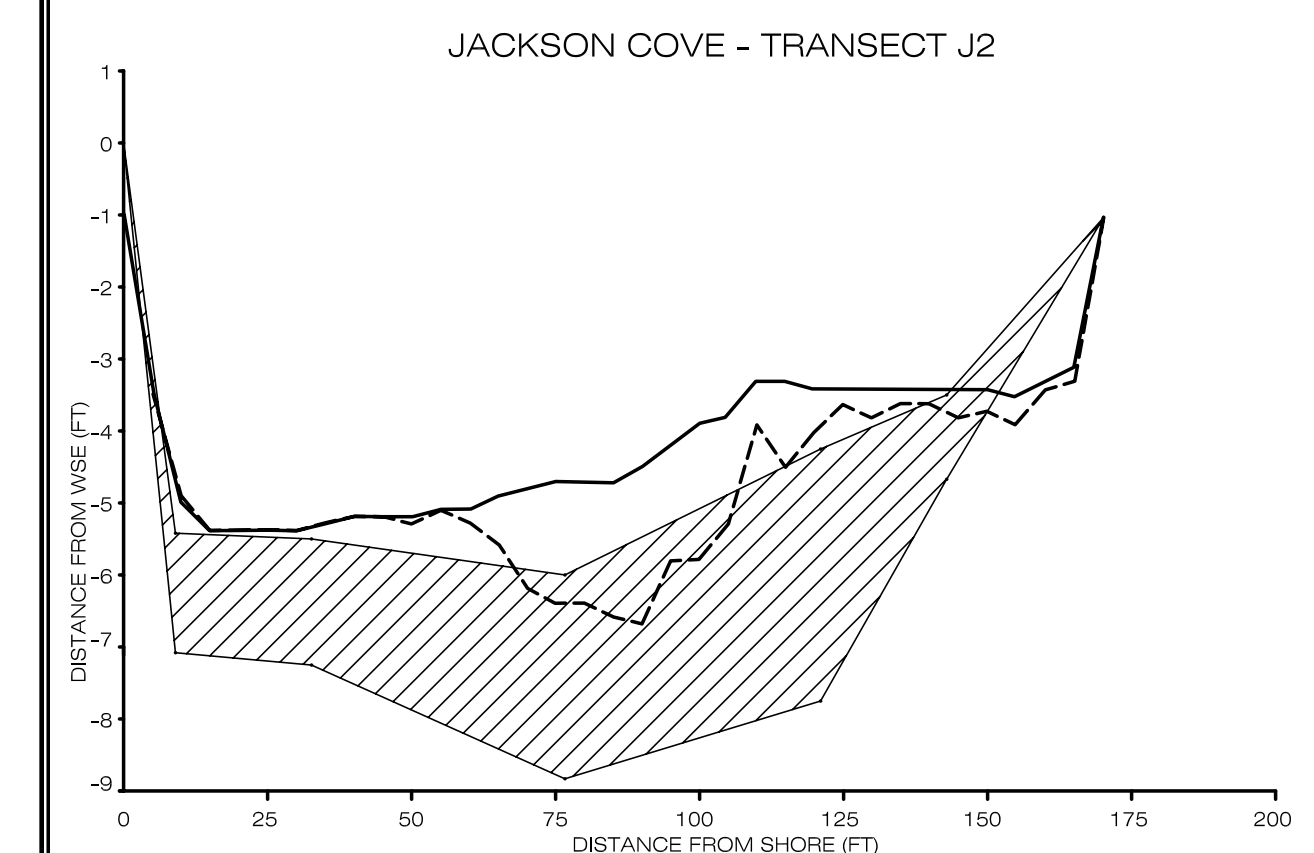
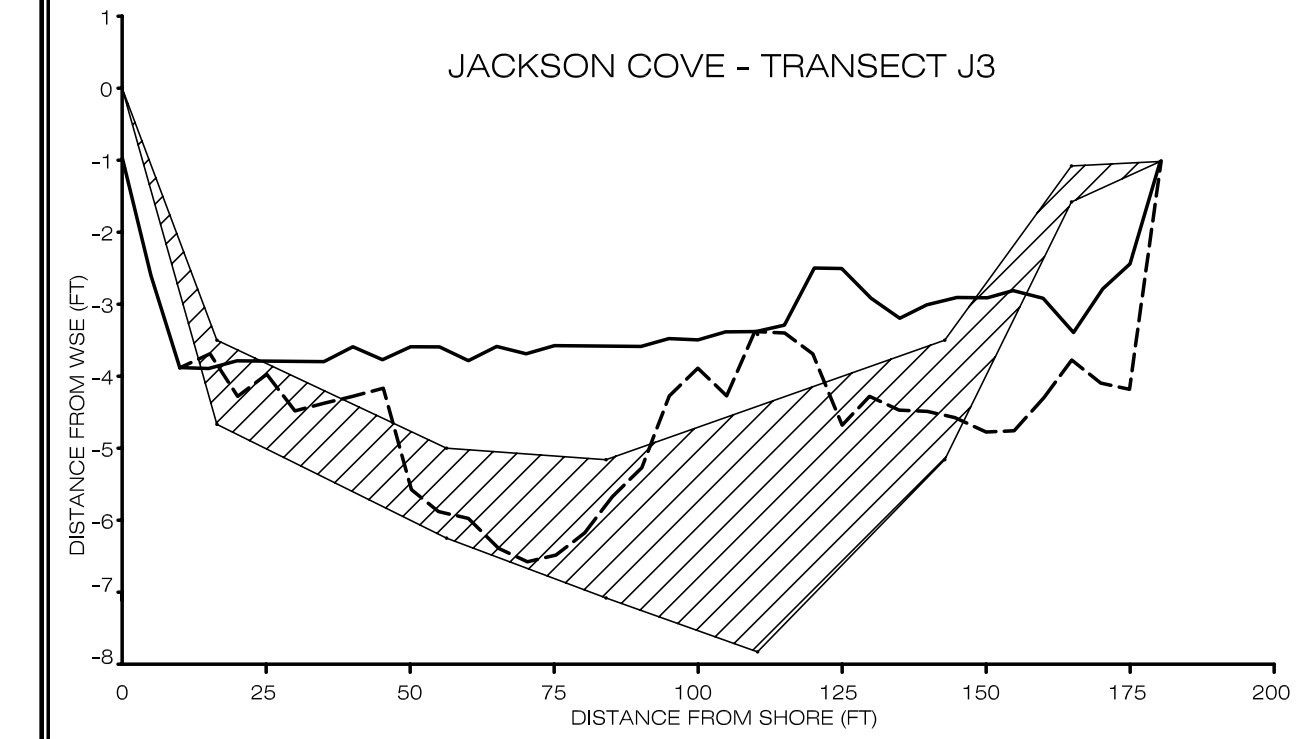
- PRE DREDGING LAKE BOTTOM 1998
- POST DREDGING LAKE BOTTOM 1998
- OBSERVED LAKE BOTTOM 2004
- OBSERVED SOFT SEDIMENT LIMIT 2004
- OBSERVED SOFT SEDIMENT LAYER 2004

NOTE:
The transects were located in the field in approximate fashion using observable landmarks and GPS instrumentation. No survey-level horizontal control was established.
